Prior, S.¹*, Marsden, C.², and Wowk, D.¹

Keywords: low velocity impact, barely visible impact damage, sandwich panel

ABSTRACT

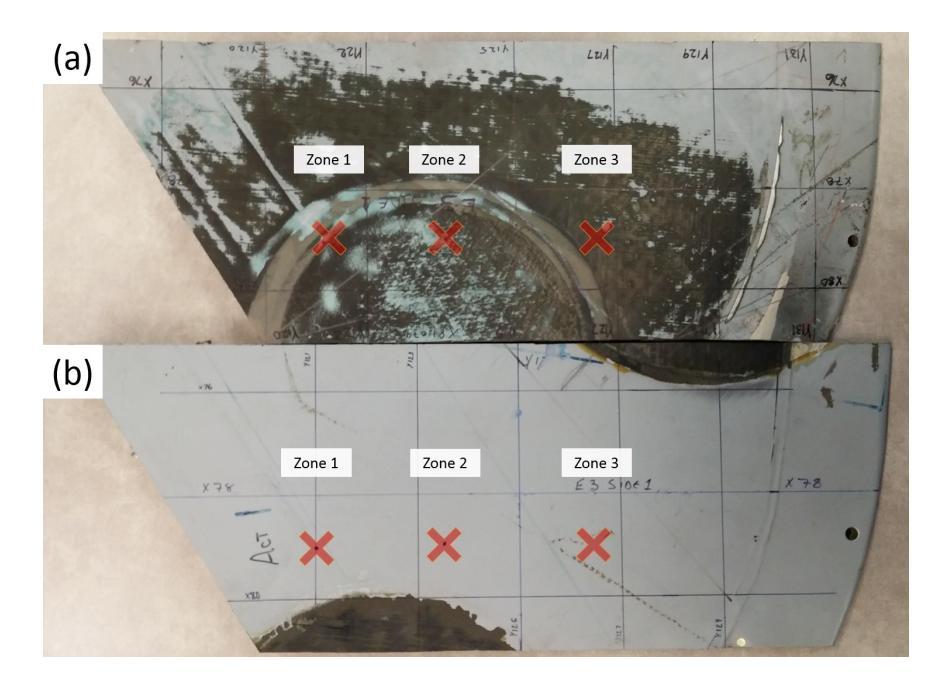
This study focused on how damage from low-velocity impact differs between a repaired and an unrepaired panel (2). The stiffness at a repair patch is higher due to an increased effective facesheet thickness because of the additional plies, but there are additional factors that may influence the failure mode or the detectability of damage such as the presence of potting compound, foaming adhesive, additional plies, and challenges with performing a proper repair (for example, ensuring that the repair patch is well bonded to the underlying sandwich panel). The same locations were all impacted at 5 J with a 25.4 *mm* steel impactor on two otherwise identical panels. Figure 9 shows the two panels, and the impact locations identified as zone 1, 2 and 3 respectively for the unrepaired and repaired panels. One impact was on the edge of the ramp of the repair (zone 1), another in the middle of the repair (zone 2), and a third just outside the repair patch (zone 3).

Figure 9. (a) Repaired panel with patch and (b) unrepaired panel. For the repaired panel, zone 1 is along the edge of the repair where the plies and thickness begin to taper off, zone 2 is in the center of the repair where there is increased effective facing thickness of the patch/panel combination, and zone 3 is just outside the repair patch.

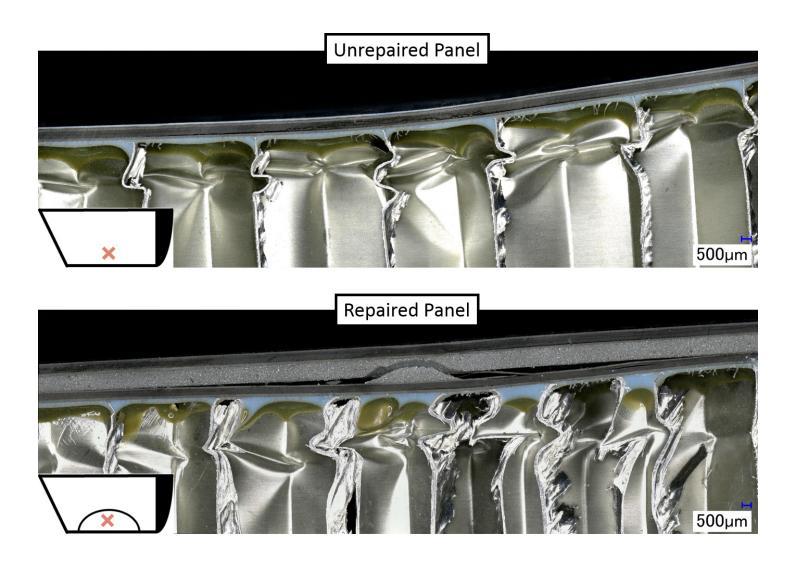
Damage cross sections at zone 2 for the unrepaired and repaired panel are shown in Figure 10. Zone 2 for both panels had significant underlying damage, but the repaired panel has a much smaller external indentation than does the unrepaired panel. This is a result of the failure of the potting compound between the patch and the facesheet, allowing for the facesheet to rebound. Multiple modes of failure occurred underneath the repair patch as seen in Figure 11, including delamination, potting compound fracture and core crushing. The facesheet laminate has some delamination initiating, and the repair patch has a delamination starting underneath the second ply which has a reverse pine-tree fracture, causing delamination in the lower plies as is characteristic of thick laminates [5].

Figure 10. Unrepaired and repaired panel zone 2 cross-sections.

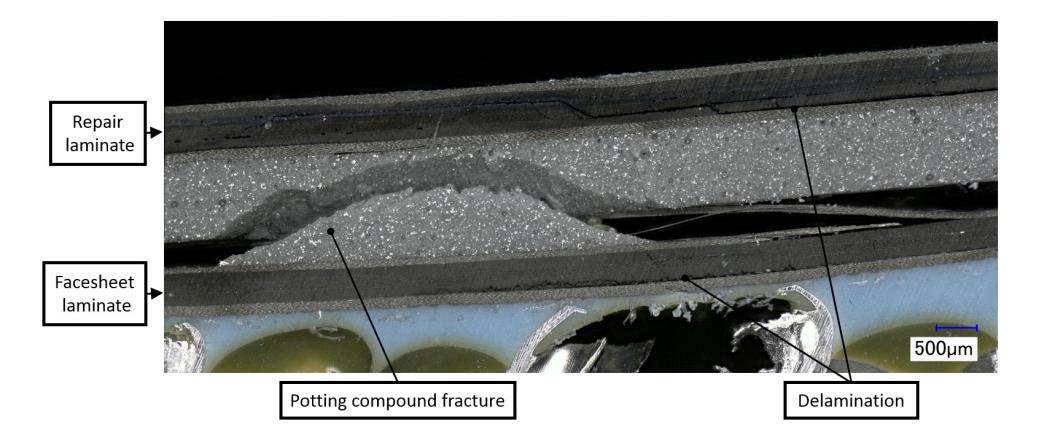
Figure 11. Repaired panel zone 2 delamination and damaged potting compound.

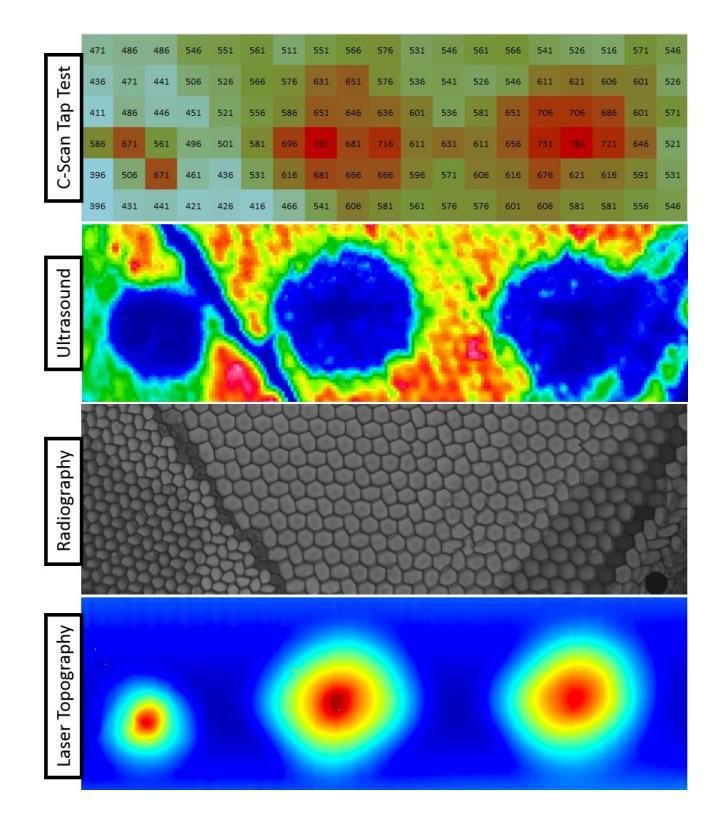
Figure 12 shows the NDI results for the unrepaired panel. Each impact was performed with a 25.4 *mm* steel impactor at 5 J. The C-scan tap test, through transmission ultrasound and laser topography easily show the damage and dent size. Note that radiography shows the core splice separating the 3.1 *pcf* core on the left from the 2.3 *pcf* core on the right (this is the same underlying structure as the repaired panel). Increased core density results in decreased damage diameter (as seen from the C-scan tap test and through-transmission ultrasound) and dent diameter (as seen from the laser topography) for a given impact energy level.

Figure 12. Unrepaired specimen NDI results. The core splice separates the 3.1 *pcf* core (left) from the 2.3 *pcf* core (right). Impact on the higher density core leads to decreased damage and dent diameter for a given energy level.

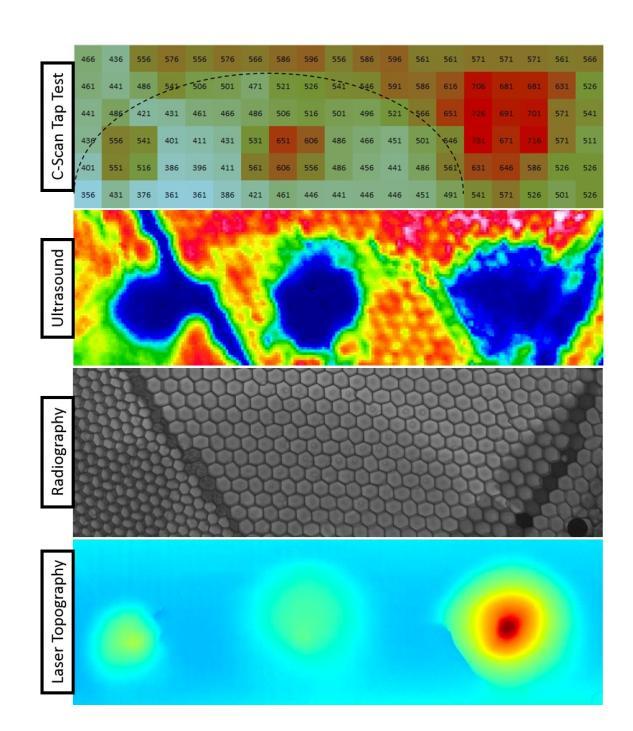
Figure 13 shows the NDI results for the repaired panel. The dashed line for the C-scan tap test outlines the patch which is detectable due to the decreased contact time. The patch is also noticeable in the ultrasound and laser topography scans, while it is barely detectable in the radiographic image as a shadow. The impact in the center of the repair patch led to a minimal dent depth (i.e. BVID) as can be seen by the laser topography deviation map in Figure 14. It should be noted that even analysis of only the post impact laser topography would reveal the impact as seen in Figure 13, even though visually the dent was not detectable and the micrometer only measured 101 μm . The laser topography does pick up the dent even though it is BVID, so this can be considered an effective NDI technique. The micrometer is not as accurate for dent profile measurements particularly for real life panels with facing thickness changes and curvature. This should be a consideration when developing inspection procedures for repair manuals, as real panels are not as easily measured as standardized coupons.

Figure 13. Repaired specimen NDI results. The dashed line indicates the patch. The zone 2 impact is BVID but detectable with the C-scan tap test, ultrasound and laser topography deviation map.

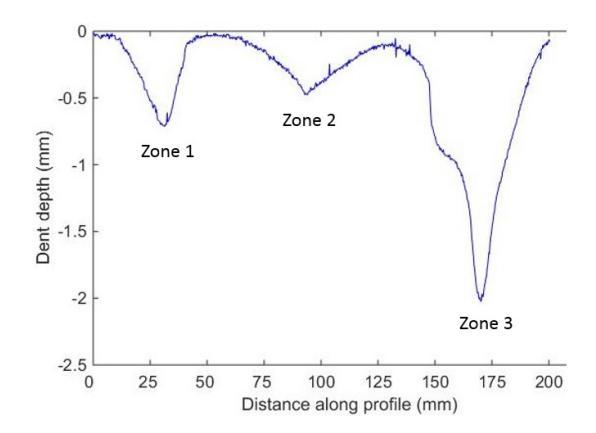
Zone 3 (the location just outside of the repair patch) experienced greater dent depth and laminate damage than the unrepaired panel. The repair patch appears to have acted as a boundary condition of greater fixity; being adjacent to a stiffer region does not allow much deformation so this appears to have led to greater damage.

Figure 14. Post-impact laser topography dent depth profile across the repair patch and three impacts.
