LOW VELOCITY IMPACT ASSESSMENT OF KEVLAR/FLAX-EPOXY COMPOSITE USING IR THERMOGRAPHY

Keywords: *Kevlar/Flax; Low Velocity Impact, Infrared Thermography*

ABSTRACT

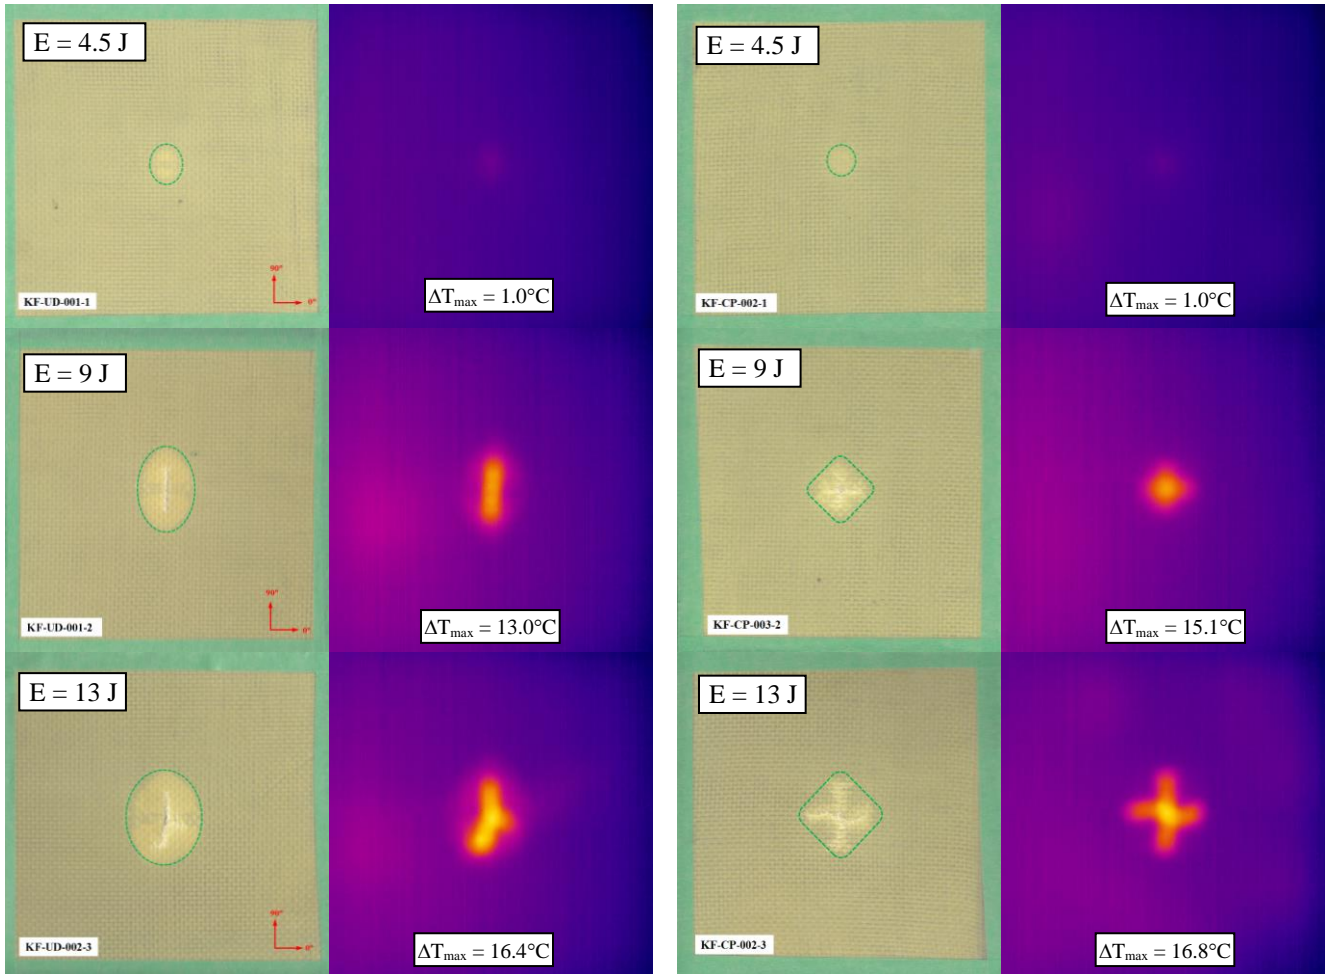
Figure 6. Back face visual damage and corresponding thermal signature for unidirectional (left) and cross ply samples (right)

Figure 6 shows the visual and thermographic (IR) images of the back face area post-impact. For a low impact energy ($E_{\text{impact}} = 4.5$ J), the damage to the back face is minimal and is manifested by slightly whitened area of about few millimeters in diameter. An examination of the thermal images for both the unidirectional and cross ply configurations shows a very small hot spot behind the impact point with a temperature rise of $\Delta T < 2^\circ\text{C}$. This small ΔT suggests that the damage mechanism for this impact energy level includes only matrix deformation and some matrix cracking. This behavior is consistent with brittle polymer matrices, where the energy required for matrix deformation and cracking is small [20], which in turn gives rise to a small temperature increase [15]. The ΔT for both configurations is almost of equal magnitude, although the unidirectional samples show slightly larger whitened area as compared to the cross ply sample. This behavior can be attributed to the difference in the flexural stiffness between the two laminates, with the unidirectional laminates being stiffer (thus more brittle) than the cross ply ones.

At higher impact energies (9 J and 13 J), the damage to the back face of the samples becomes more prominent with obvious signs of macro cracks and delamination. The delamination area and crack length also increases with increasing energy level. For the unidirectional samples, the macro-crack propagates in the direction normal to the flax fibers. The IR images show the crack originating at the point of impact where ΔT is at maximum, and propagates normal to the flax fiber direction (ΔT decreasing away from the central hot spot). This transverse crack propagation indicates the occurrence of fiber breakage in the laminate. Surrounding the crack are slightly cooler zones, which may be due to delamination of the outer fiber layers from the matrix. At 9 J impact energy, the crack is only visible in the transverse (90°) direction, indicating that fiber breakage only occurred within the flax-epoxy layers. At 13 J, the crack also started to propagate in the longitudinal direction of the laminate, indicating that the crack has extended into the woven Kevlar layers. This can also be seen from the third IR image in Figure 6(a), as the hot spot starts to extend into the 0° direction of the laminate. It must be noted, however, that although the crack seemed to have extended to the Kevlar layers, the impact energy was not high enough to cause complete breakage

of the Kevlar fibers. For the cross ply laminates, the cracks propagate in both the longitudinal and transverse directions of the laminate, with the crack lengths almost equal in both directions.
