## UNDERSTANDING THE NATURAL AGING OF GFRP COMPOSITES: A LONGITUDINAL STUDY

### ABSTRACT

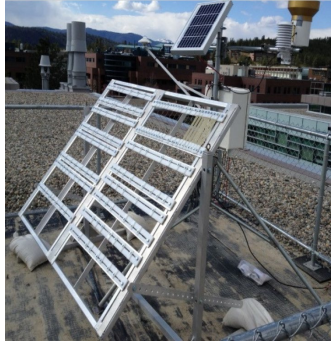
**Figure 1:** The set-up used for the natural ageing of test specimens

As shown in Figure 1, samples were placed on top of an unobstructed roof and were installed on an adjustable aluminium rack with their flat mould side facing upwards. The natural ageing experiment started in February 2014 (winter) in this study and took for one year. All plates were oriented towards the sun during the ageing period with a  $45^\circ$  of inclination to maximise the absorption of UV sunlight and prevent any potential pooling of water. To avoid any contamination from the rack structure, samples were manually fixed by clamps made of ultra-high molecular weight polyethylene, as shown in Figure 2.

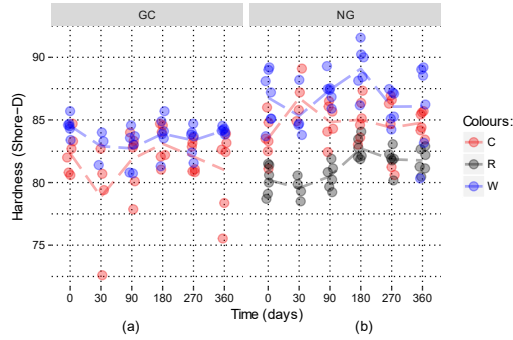
**Figure 5:** Changes in surface hardness for (a) coated and (b) un-coated samples during the ageing period; the dashed lines represent the trends for the average values, while the points depict each measurement

The effect of gel coat in maintaining the surface quality is also detectable through changes in hardness, as the gel coat film similarly limited shifts in hardness values during the exposure period (Figure 5-a). For all uncoated samples, hardness was mostly decreasing during the humid winter, with a relatively steeper drop experienced by woven types (between the days 180 and 270 in Figure 5-b).

In composites with continuous fibres, moisture sorption is through the combined action of diffusion in matrix and capillarity along fibres (either diffusion through fibres or cracks at fibre-matrix interface region) [2, 4, 22]. These types of composites are proven to be more diffusive along their fibres rather than through their matrix structure [7, 23]. In these types, hydrolysis reaction contributes to the weakening of fibre-matrix bonds [20, 14]. Then, differential swelling stresses [24, 8, 11], together with the dissolution of fibres sizing in the absorbed water [9, 25], ultimately leads to interfacial debonding, the known prevalent damage among aged composites with woven fabric reinforcements [2, 22]. The additional free volume in woven types [2, 26, 27, 20, 28], imposed by this interfacial debonding [29], means their more potential for moisture ingress, and thus, the sharper reduction of hardness during the wet and humid seasons (between the days 180 and 270 in Figure 5-b).

All types of samples were generally gaining hardness during the sunny season of the ageing period (between the days 30 and 180 in Figure 5-b). This hardness gain would be representative of post-curing and polymerisation of un-reacted monomers under the action of sunlight UV radiation [30, 7, 31, 32]. Indeed, before the outset of photo-degradation, the two latterly discussed phenomena (polymerisation and post-cure crosslinking) lead to the chains with a higher molecular weight and stronger intermolecular bonds, ultimately resulting in a stiffer matrix structure.

internal layers from UV radiation and invasion of oxygen [4]. As a result, applying a layer of coating film, as a frontline barrier against UV, can effectively limit the ageing-induced shifts in hardness (Figure 5-a). Given the softer structure of the applied gel coat compared to the matrix, coated samples, however, were generally of lower value in their hardness than their uncoated counterparts during this experiment.

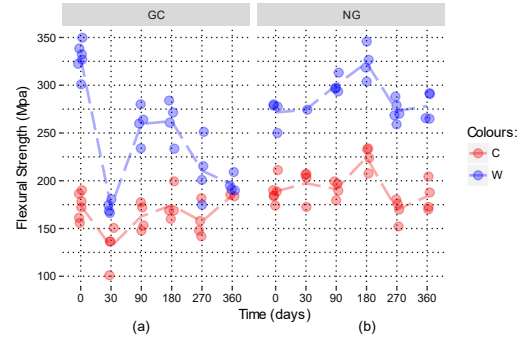
**Figure 6:** Changes in flexural strength for (a) coated and (b) un-coated samples during the ageing period; the dashed lines represent the trends for the average values, while the points depict each measurement

Similar to the weathering-induced changes in hardness values, the rise in the flexural strength (Figure 6) was under the action of sunlight UV radiation (post-curing and polymerisation effect) in our experiment, while its drop (Figure 6) was vastly under the influence of moisture ingress (plasticisation and affected interfacial bonds). For coated samples, the decline in the flexural strength, experienced within the first 30 days of ageing (Figure 6-a), was probably due to debonding of the coating layer from the resin bulk, shown in Figure 7. The additional interface imported by the coating application, and its subsequent debonding, may inflict the uptake of destructive agents, like moisture and oxygen, leading to the degradation of constituents [33]. This decline was found to be even sharper for coated samples with continuous fibres (Figure 6-a), where the debonding also followed the fibre path (depicted by red arrows in Figure 7).

Uncoated fibre reinforced samples, however, were all declining in their flexural strength quite similarly during the wet season and regardless of their fibre preform architecture (see Figure 6-b in the interval between the days 180 and 270). Using a micro-CT tomography inspection, two distinct mechanisms are found here to degrade the flexural properties in these two types, but with quite similar impacts. The weakened fibre-matrix bonds (Figure 8), mainly caused by moisture absorption, lead to the decline in flexural strength for composites with continuous fibres [2, 22], while for chopped fibre reinforced GFRPs, matrix degradation (ageing-induced defects in the matrix, like bubbles and microcracks, as shown in Figure 9) is known as the chief cause of this reduction [34].
