FAILURE CHARACTERIZATION OF LAMINATION EPOXY UTILIZING 3D DIGITAL IMAGE CORRELATION UNDER DIFFERENT LOADING CONDITIONS

Elruby, A.^{1*}, and Nakhla, S.²

Keywords: *Failure, Lamination Epoxy, 3D DIC*

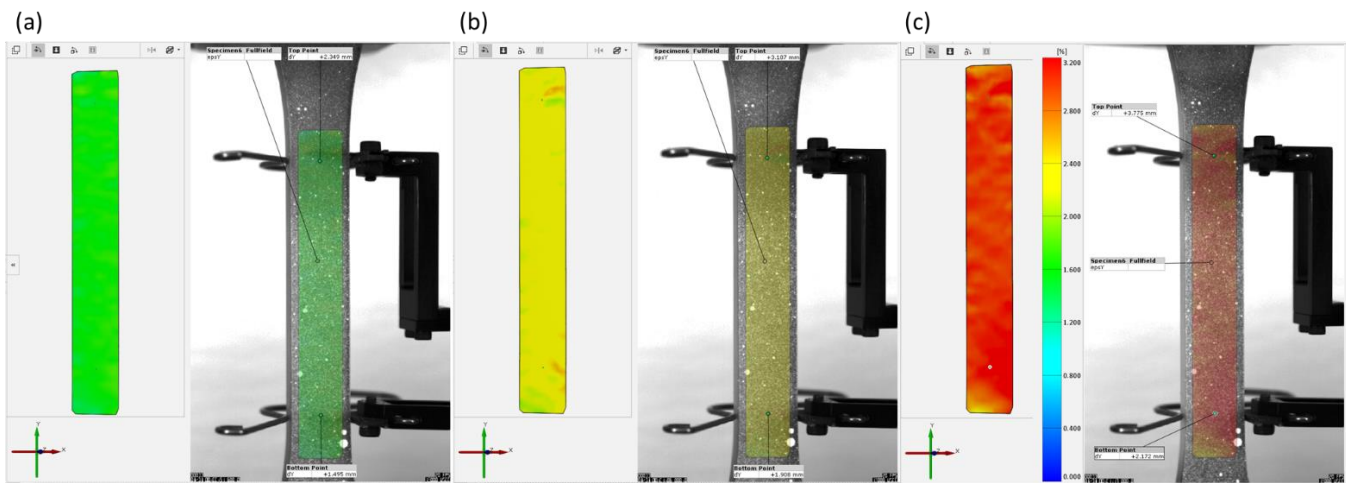
Figure 5. Full-field strain measurements along the longitudinal direction from the DIC analysis at different time frames: (a) 51 sec (b) 66 sec (c) 77 sec

Full-field strain measurements from DIC analysis using GOM Correlate Professional are depicted at different time frames in Figure 5. Each figure is showing the strain field individually and superimposed on the specimen T5 during the test. The last time frame was a few seconds before the final failure. Noteworthy to mention, that an extra step of validating the DIC measurements was performed by attaching a physical extensometer to the gauge length of the specimen. A virtual extensometer was utilized in the software to match the physical one. Both results were compared and they were identical.
