## Mechanical Analysis of Step-Step Wet Lay-Up Repairs: Experimental Approach

**Keywords:** *Composite; Repairs; Stepped-lap joint; Wet Lay-Up*

**Abstract:** This study investigates the tensile performance of step-step bonded repairs manufactured using a wet lay-up process and applied to monolithic composite laminates. Nine repair configurations were evaluated experimentally to quantify the influence of three key parameters: the resin system, the step length, and the addition of an over-ply. Three epoxy systems were compared, two aerospace-grade wet lay-up resins (Loctite® EA 9390 and EA 9396) and a low-cost marine-grade epoxy (West System 105/206). Tensile tests were performed on repaired and pristine references to determine ultimate strength and repair efficiency. Results show that EA 9390 provides the highest tensile performance across all configurations, achieving up to 85% strength restoration. Increasing the step length improves joint strength, although the trend is not linear, with diminishing gains at larger step lengths. The addition of an over-ply significantly enhances repair efficiency, particularly for EA 9396. Overall, the study provides a systematic experimental as

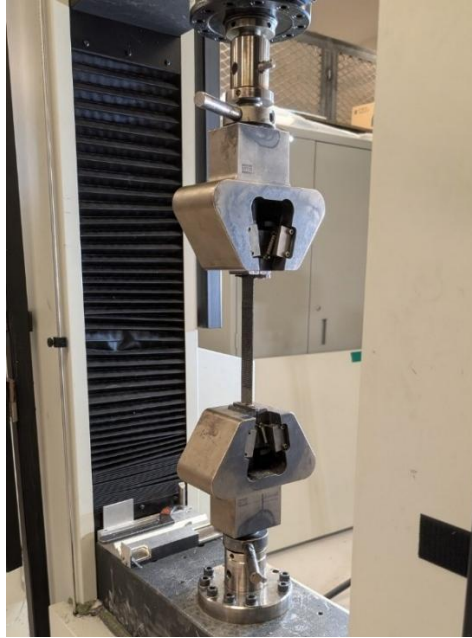
The specimens were cut from the repaired plates (see Figure 1) using a water-cooled diamond circular saw. After cutting, the specimens were carefully blotted and dried. They were then tested in tension at ambient temperature using an MTS Insight electromechanical testing system equipped with a 100 kN load cell. The test setup is shown in Figure 3. Self-tightening grips were used, meaning that the clamping force increased automatically as the applied load increased. A small mechanical stop on each grip ensured that the specimen was positioned centrally and aligned with the loading direction. All tests were performed at a constant crosshead displacement rate of

1 mm/min. No tabs were used, as failure consistently occurred within the gauge section. All remaining procedures followed the ASTM D8131 standard [15].

Figure 3. Photograph of the mechanical testing setup.
